UNITED STATES DISTRICT COURT
EASTERN DISTRICT OF MICHIGAN
SOUTHERN DIVISION

Civil No. 21-12886

**EMERGENCY VERIFIED MOTION FOR PRELIMINARY INJUNCTION
BY PLAINTIFF FORT IRON & METAL COMPANY**

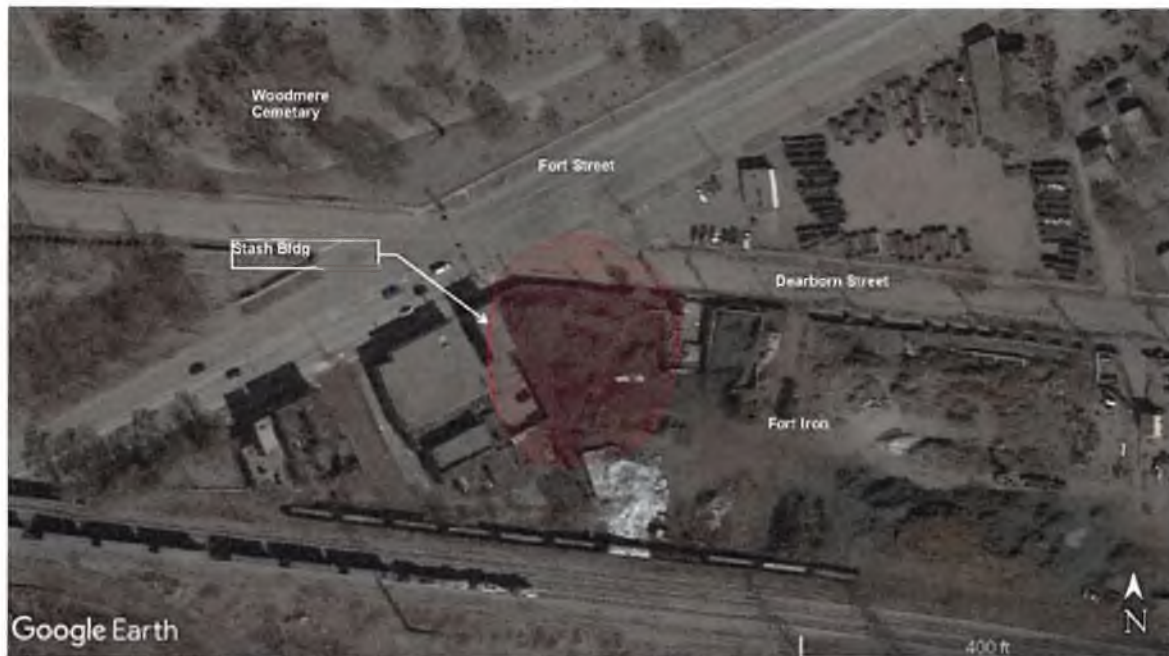
Exhibit 1 - Site Aerial Image

In total, about 1.1 acres (48,500 square feet) of plan area was impacted by the incident. The plan area of the incident is depicted in the aerial image shown below.

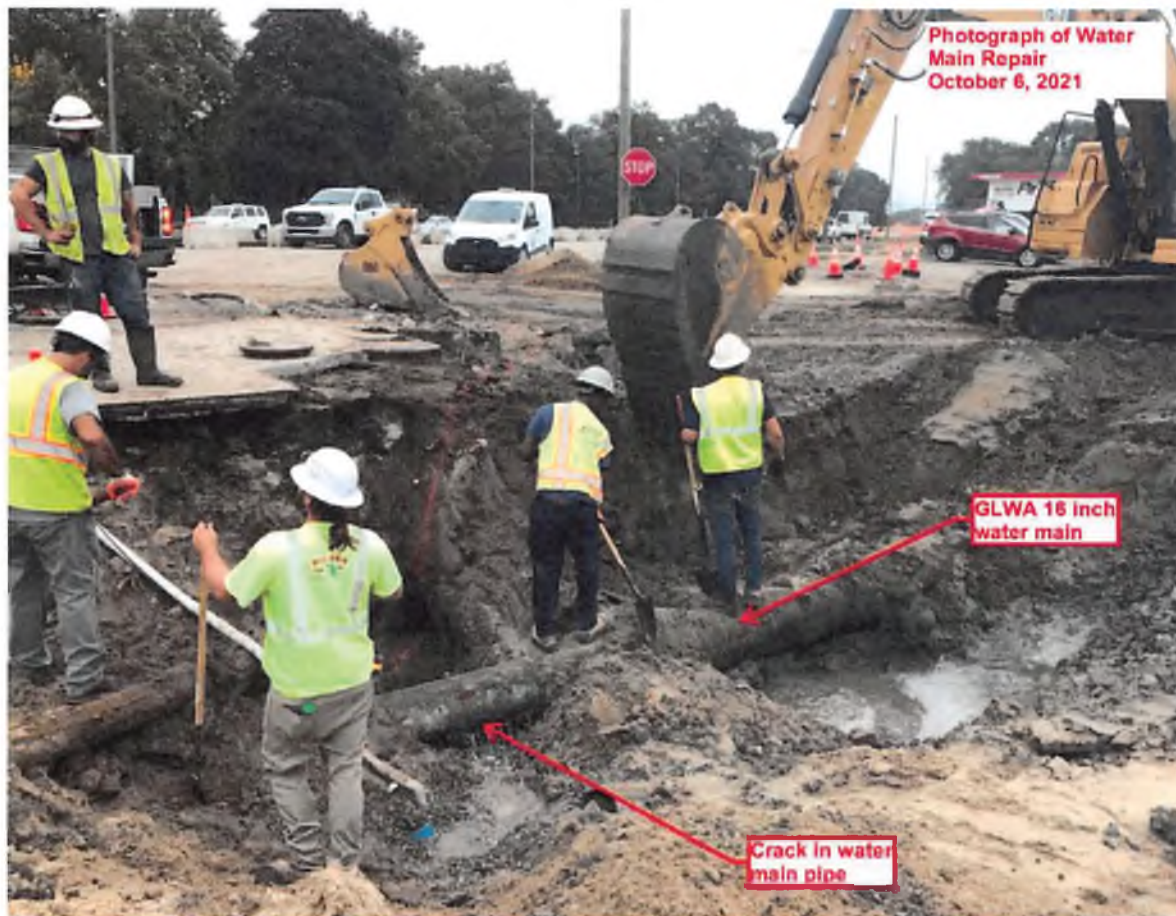
Exhibit 2 - Repair of Watermain

Further, upon investigating the GLWA watermain, only a 4-foot-long crack was observed in the pipe. The crack is shown in the photo below.

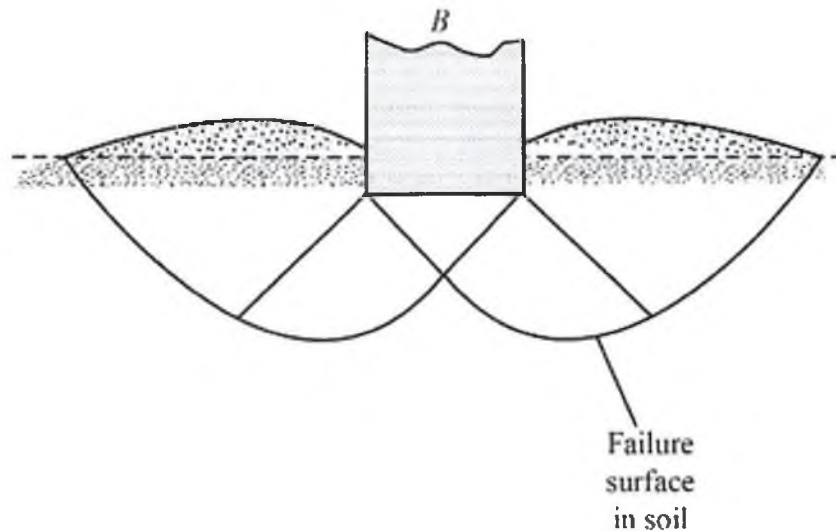
Exhibit 3 - Typical Bearing Capacity Failure Surface

A bearing capacity failure occurs when the shear stresses in the soil due to loading exceed the shear strength of the soil, and is generally classified either as a general shear failure, a local shear failure, or a punching shear failure. In a general shear failure, the load bearing area subsides, and the subsurface soil ruptures and pushes the soil up along the sides of the load.

The movement expected with this type of failure would be the dropping/downward movement of the load (mill scale) and a heaving/bulging of the soils adjacent to the load (roadway and parking lot). In addition, surface features within the heaved areas would tip or lean from vertical.

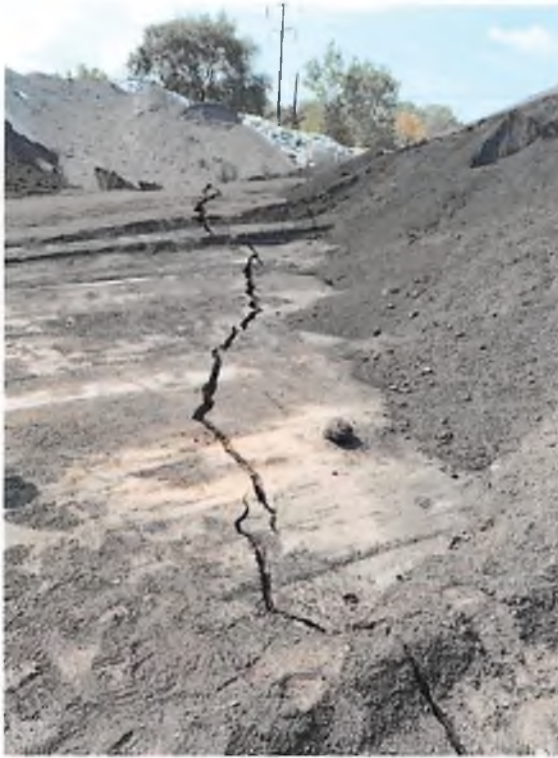
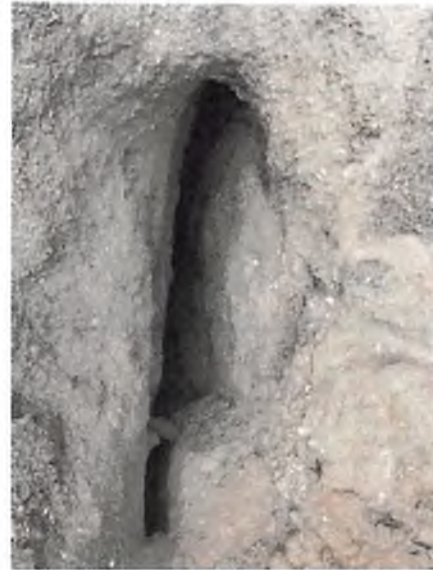
Exhibit 5 - Surface Cracking around Stockpile

In addition, the longitudinal cracks observed around the perimeter of the stockpile are indicators of this type of failure. The typical cracking observed at the site is shown in the two photos presented below, taken by Somat on September 14 and October 2, 2021.

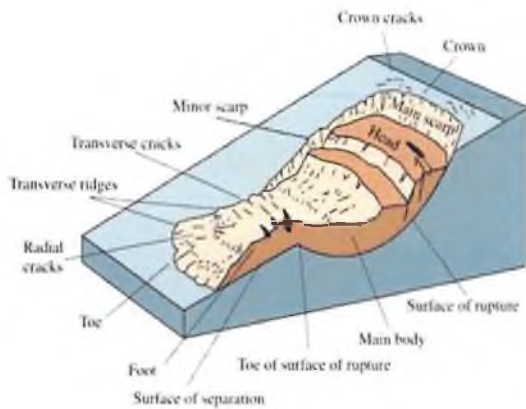
Exhibit 6 - Typical Slope Failure

Similar to a bearing failure, slope stability failures occur with a shearing of the soil along a failure surface. Slope stability refers to geometries where a slope can withstand its own weight and other forces without exhibiting movement. When the weight or forces exceed the resistance provided by the soil, movement occurs. These failure surfaces are typically circular, rotating around a point with the driving (upslope) loads being resisted by the shear strength along the circular arc and any other loads on the toe of the slope. The results of these slope failures are similar to the bearing failures: the dropping of the load (mill scale), a heaving/bulging of the soils adjacent to the load (roadway), and the tipping of surface features from vertical.

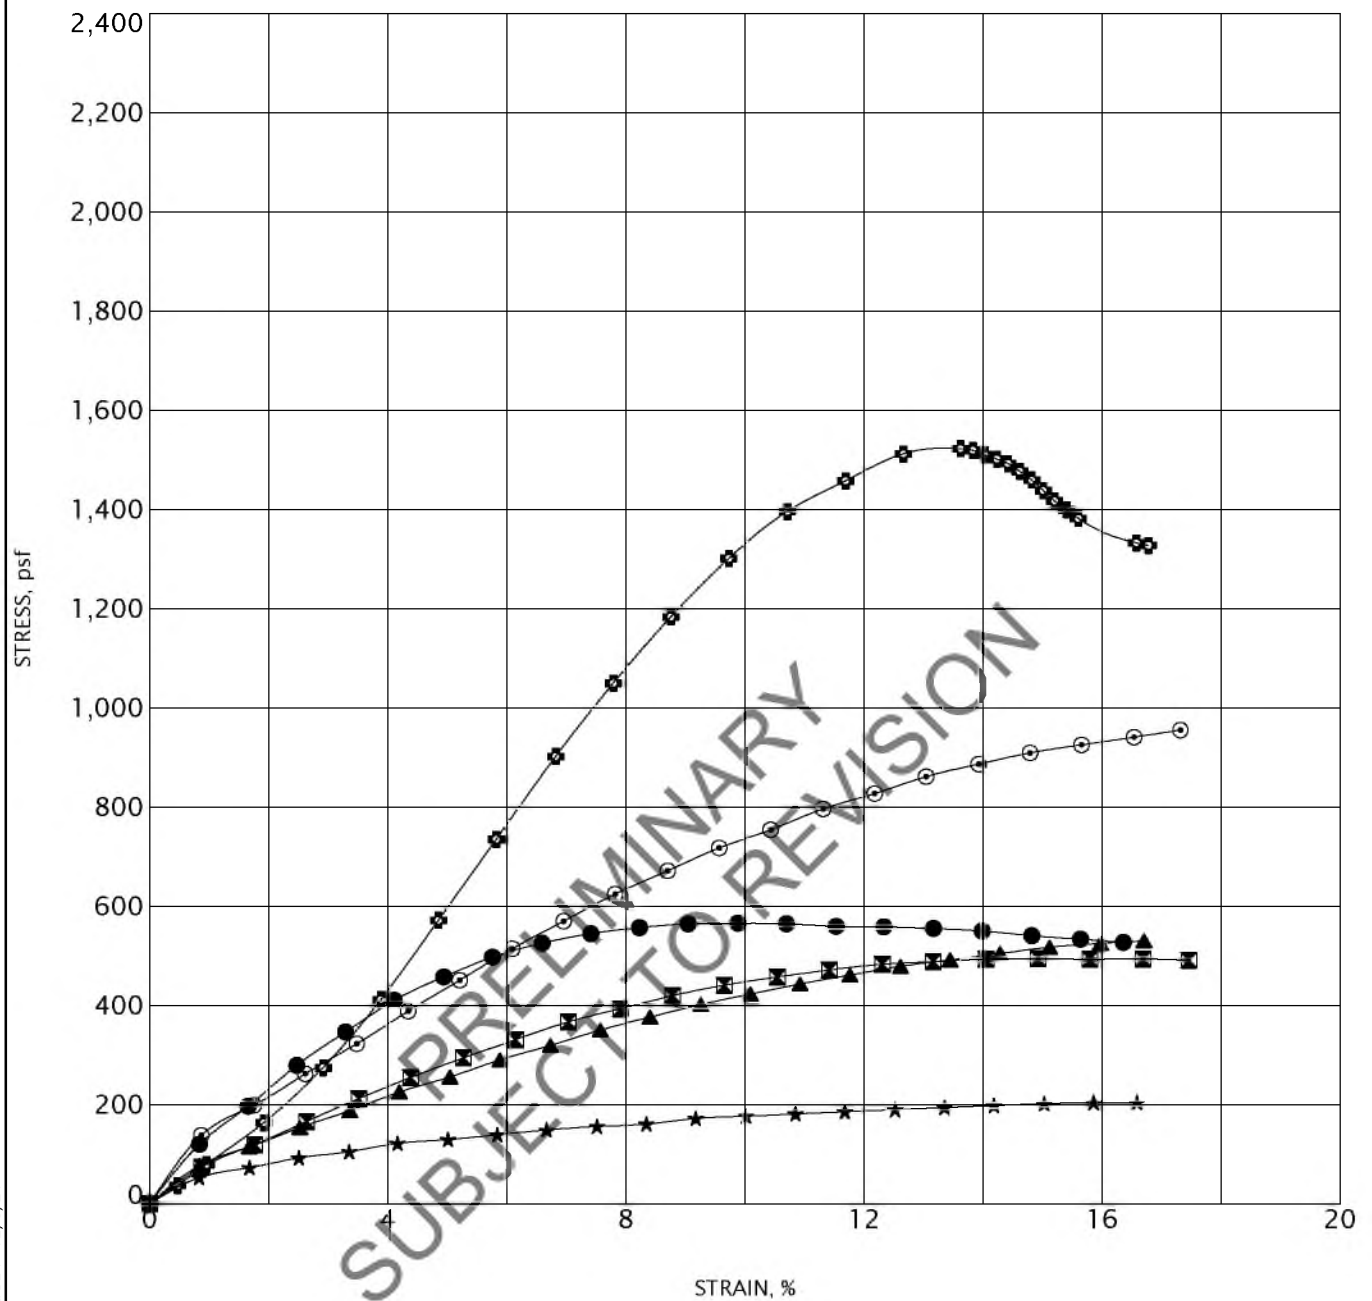
UNCONFINED COMPRESSIVE STRENGTH TEST

Specimen	Classification	MC%	γ_d	UC
● B-02 ST-16	Gray Silty Clay	45	84	570
⊠ B-02 ST-19	Gray Silty Clay	18	104	490
▲ B-02 ST-22	Gray Silty Clay	47	89	520
★ B-02 ST-34	Gray Silty Clay	26	103	200
⊙ B-02 ST-40	Gray Silty Clay	25	101	910
⊞ B-03 ST-07	Gray Silty Clay	30	97	1520

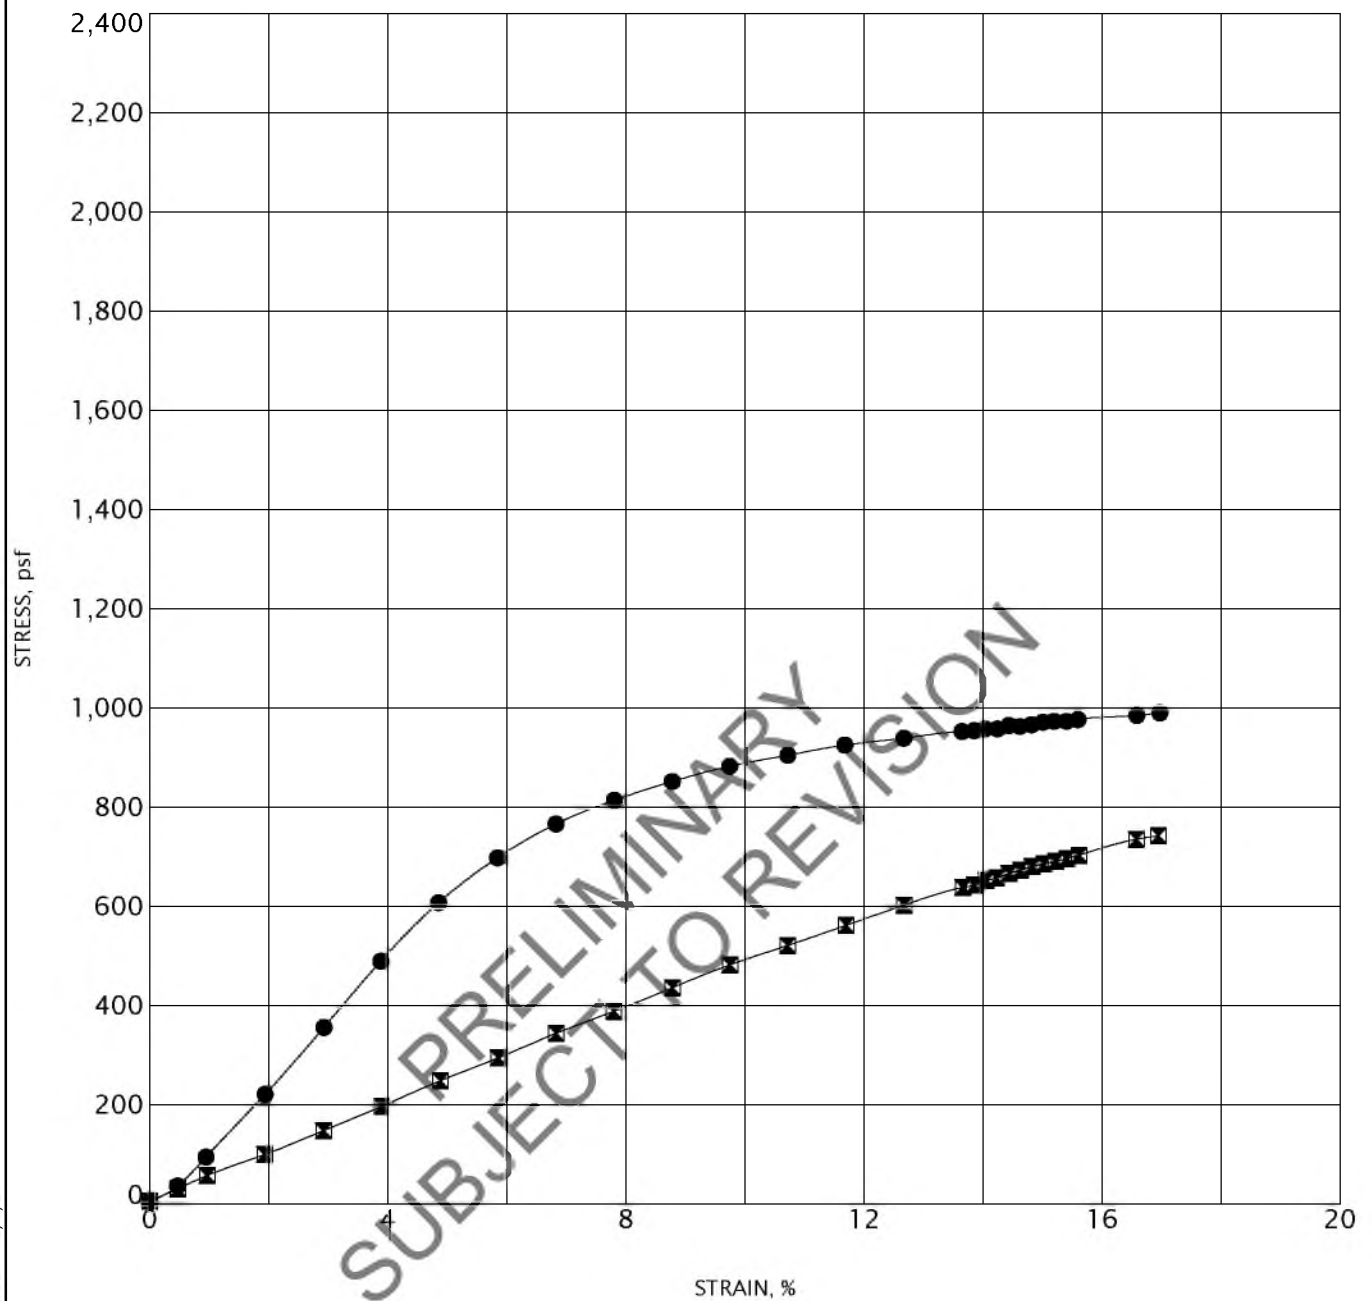
Figure No. 5

Specimen	Classification	MC%	γ_d	UC
● B-03 ST-16	Gray Silty Clay	34	84	970
■ B-03 ST-21	Gray Silty Clay	23	107	680

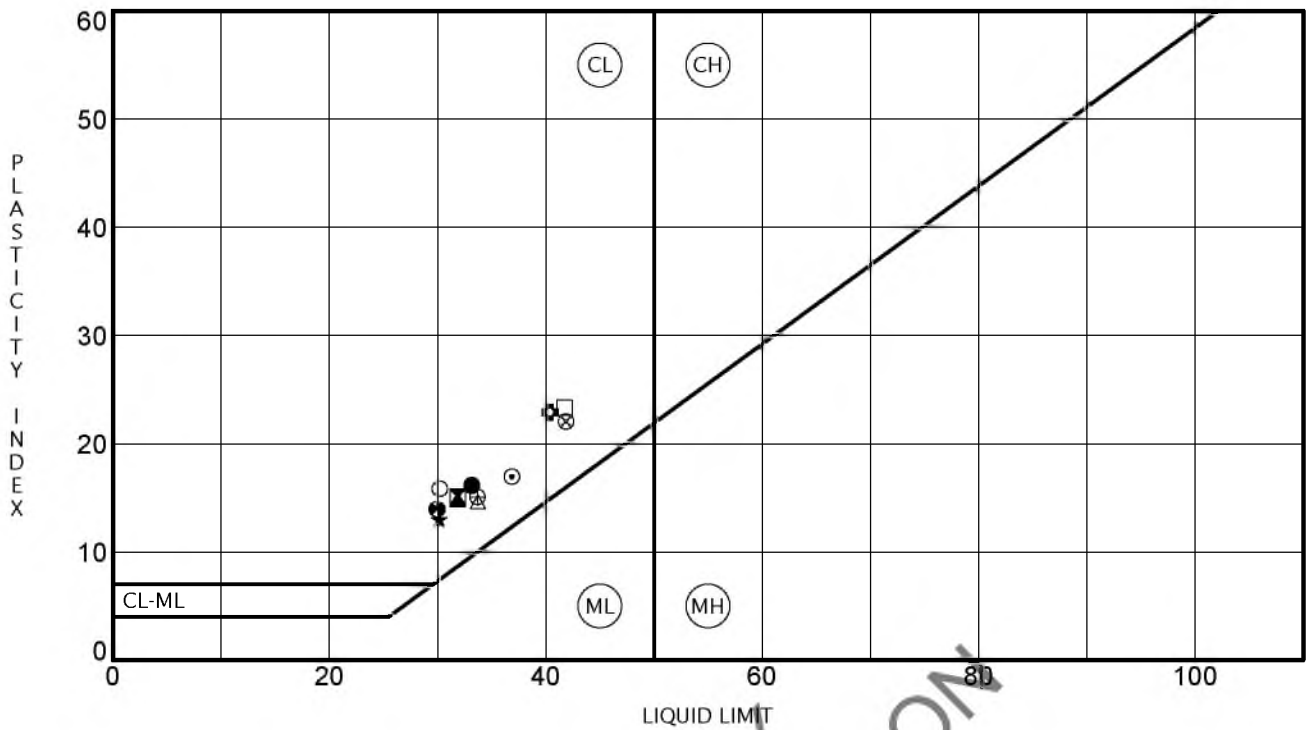
Figure No. 6

Specimen Identification	LL	PL	PI	Fines	M %	Classification
● B-01 ST-19	33	17	16		31	Gray Silty Clay
☒ B-01 ST-40	32	17	15		24	Gray Silty Clay
▲ B-02 ST-10	32	17	15		28	Gray Silty Clay
★ B-02 ST-12	30	17	13		29	Gray Silty Clay
⊙ B-02 ST-19	37	20	17		18	Gray Silty Clay
⊕ B-02 ST-22	40	17	23		47	Gray Silty Clay
○ B-02 ST-34	30	14	16		26	Gray Silty Clay
△ B-02 ST-40	34	19	15		25	Gray Silty Clay
⊗ B-02 ST-44	42	20	22		61	Gray Silty Clay
⊕ B-03 ST-07	34	19	15		30	Gray Silty Clay
□ B-03 ST-16	42	18	24		34	Gray Silty Clay
⊙ B-03 ST-21	30	16	14		23	Gray Silty Clay

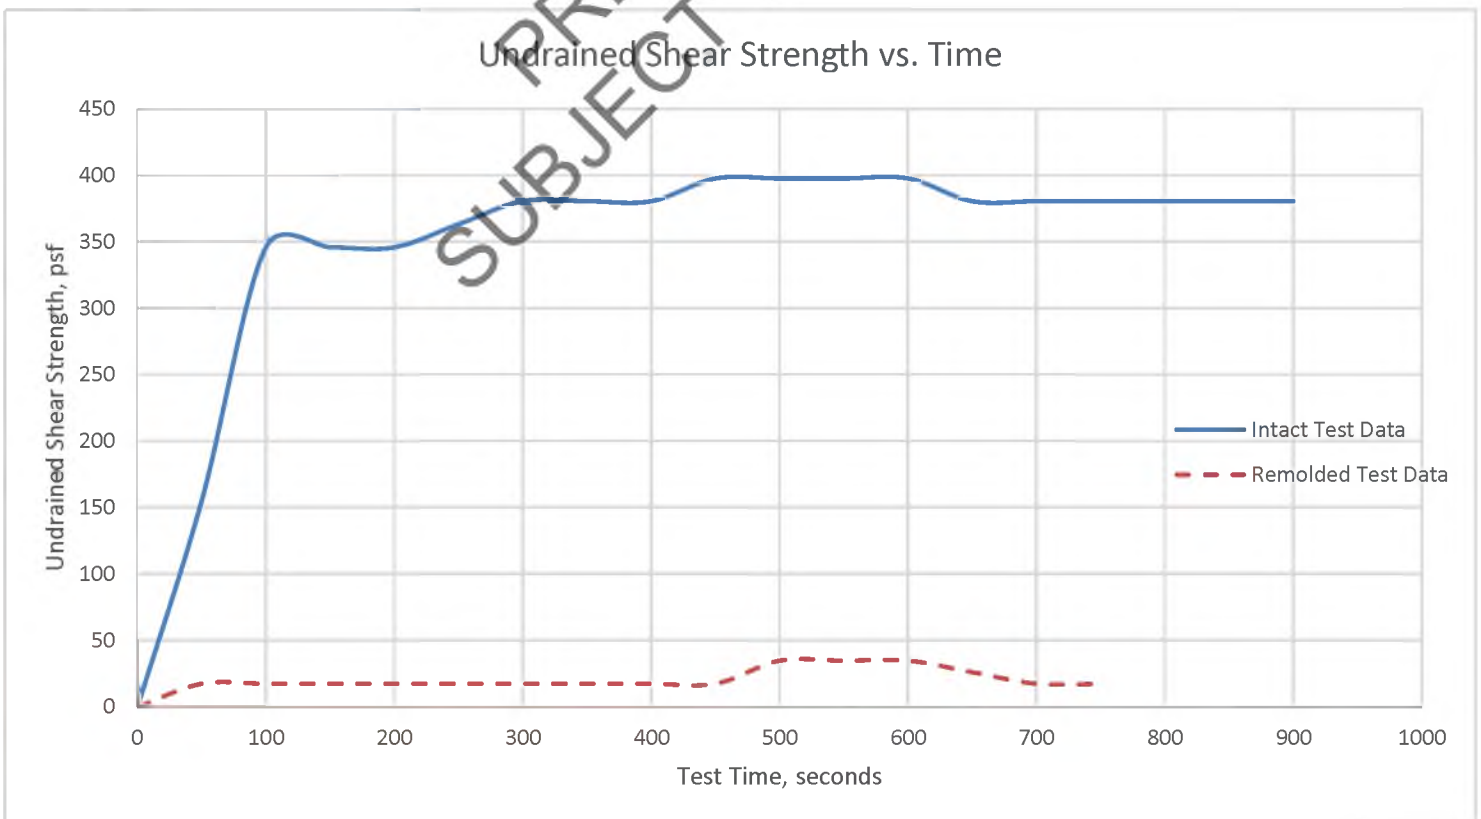
ASTM D2573**D35 - In-Situ Field Vane Shear**

Maximum Torque Reading, in-lb: 24
 No. of Remolded Revolutions: 5
 Rate of Remolding, deg/sec: 0.1
 Remolded Undrained Shear Strength, psf: 35

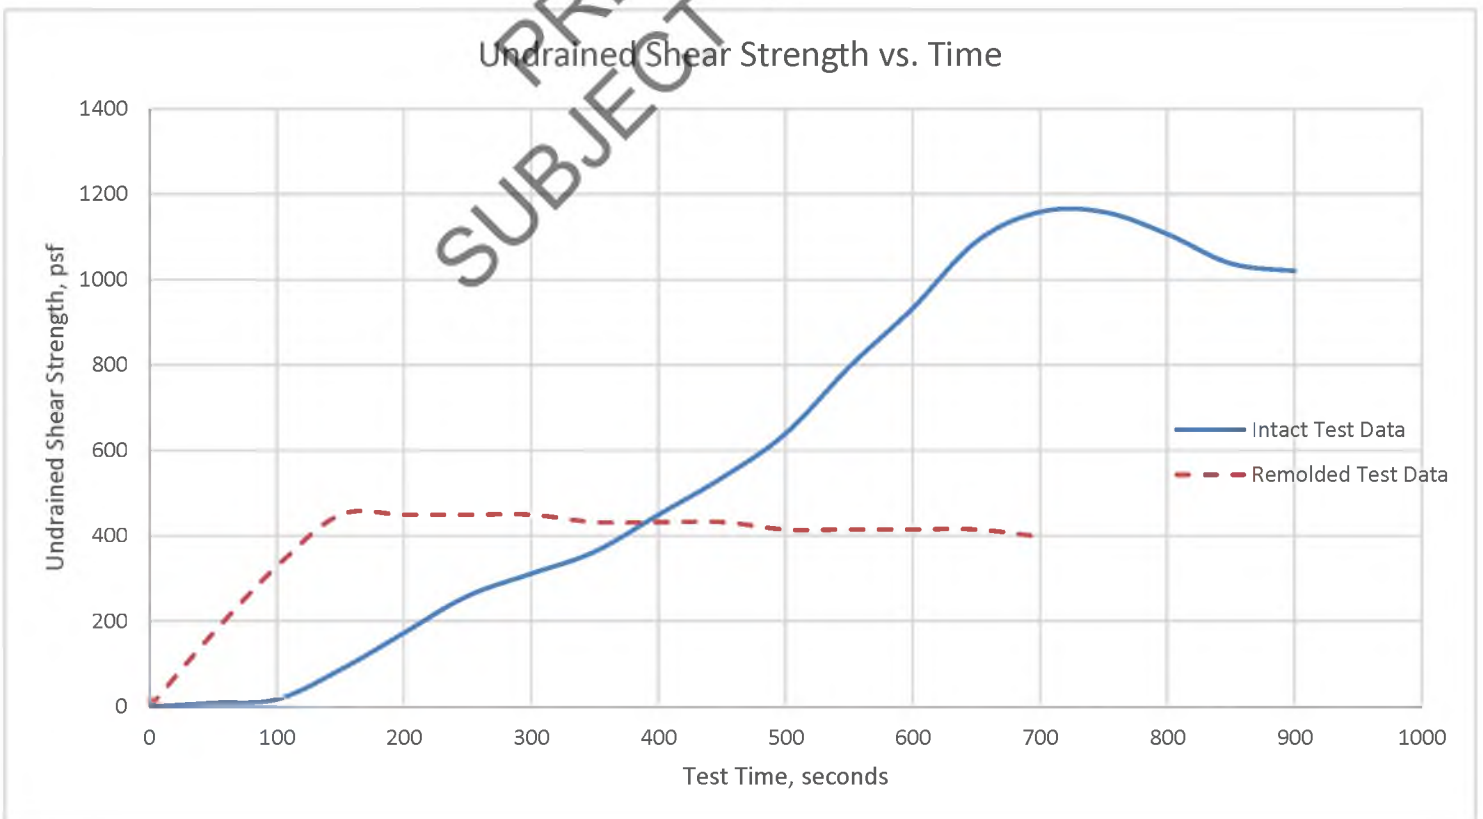
ASTM D2573**D35 - In-Situ Field Vane Shear**

Remolded Undrained Shear Strength, psf: 450

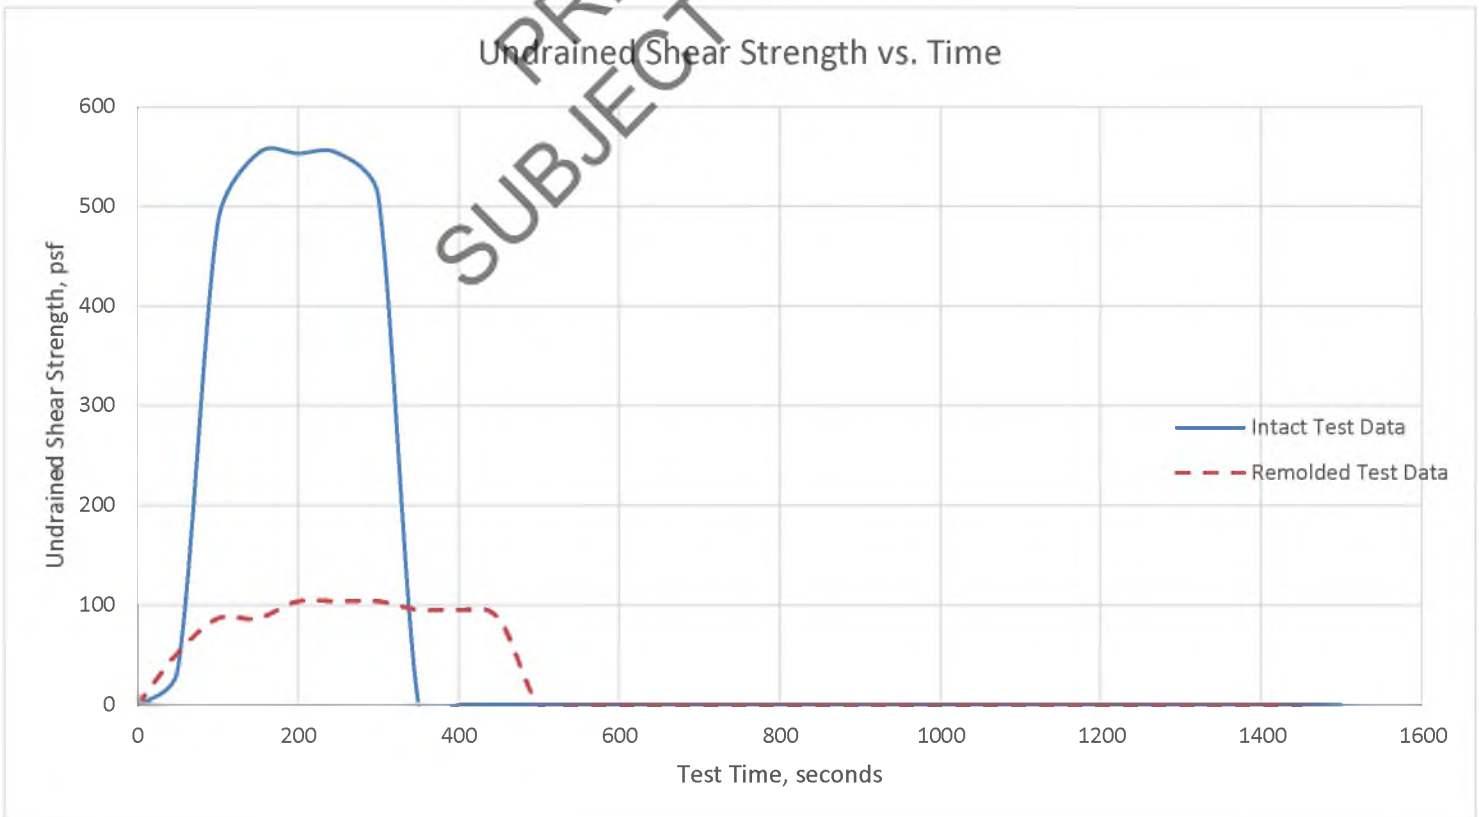
ASTM D2573**D35 - In-Situ Field Vane Shear**

Remolded Undrained Shear Strength, psf: 104

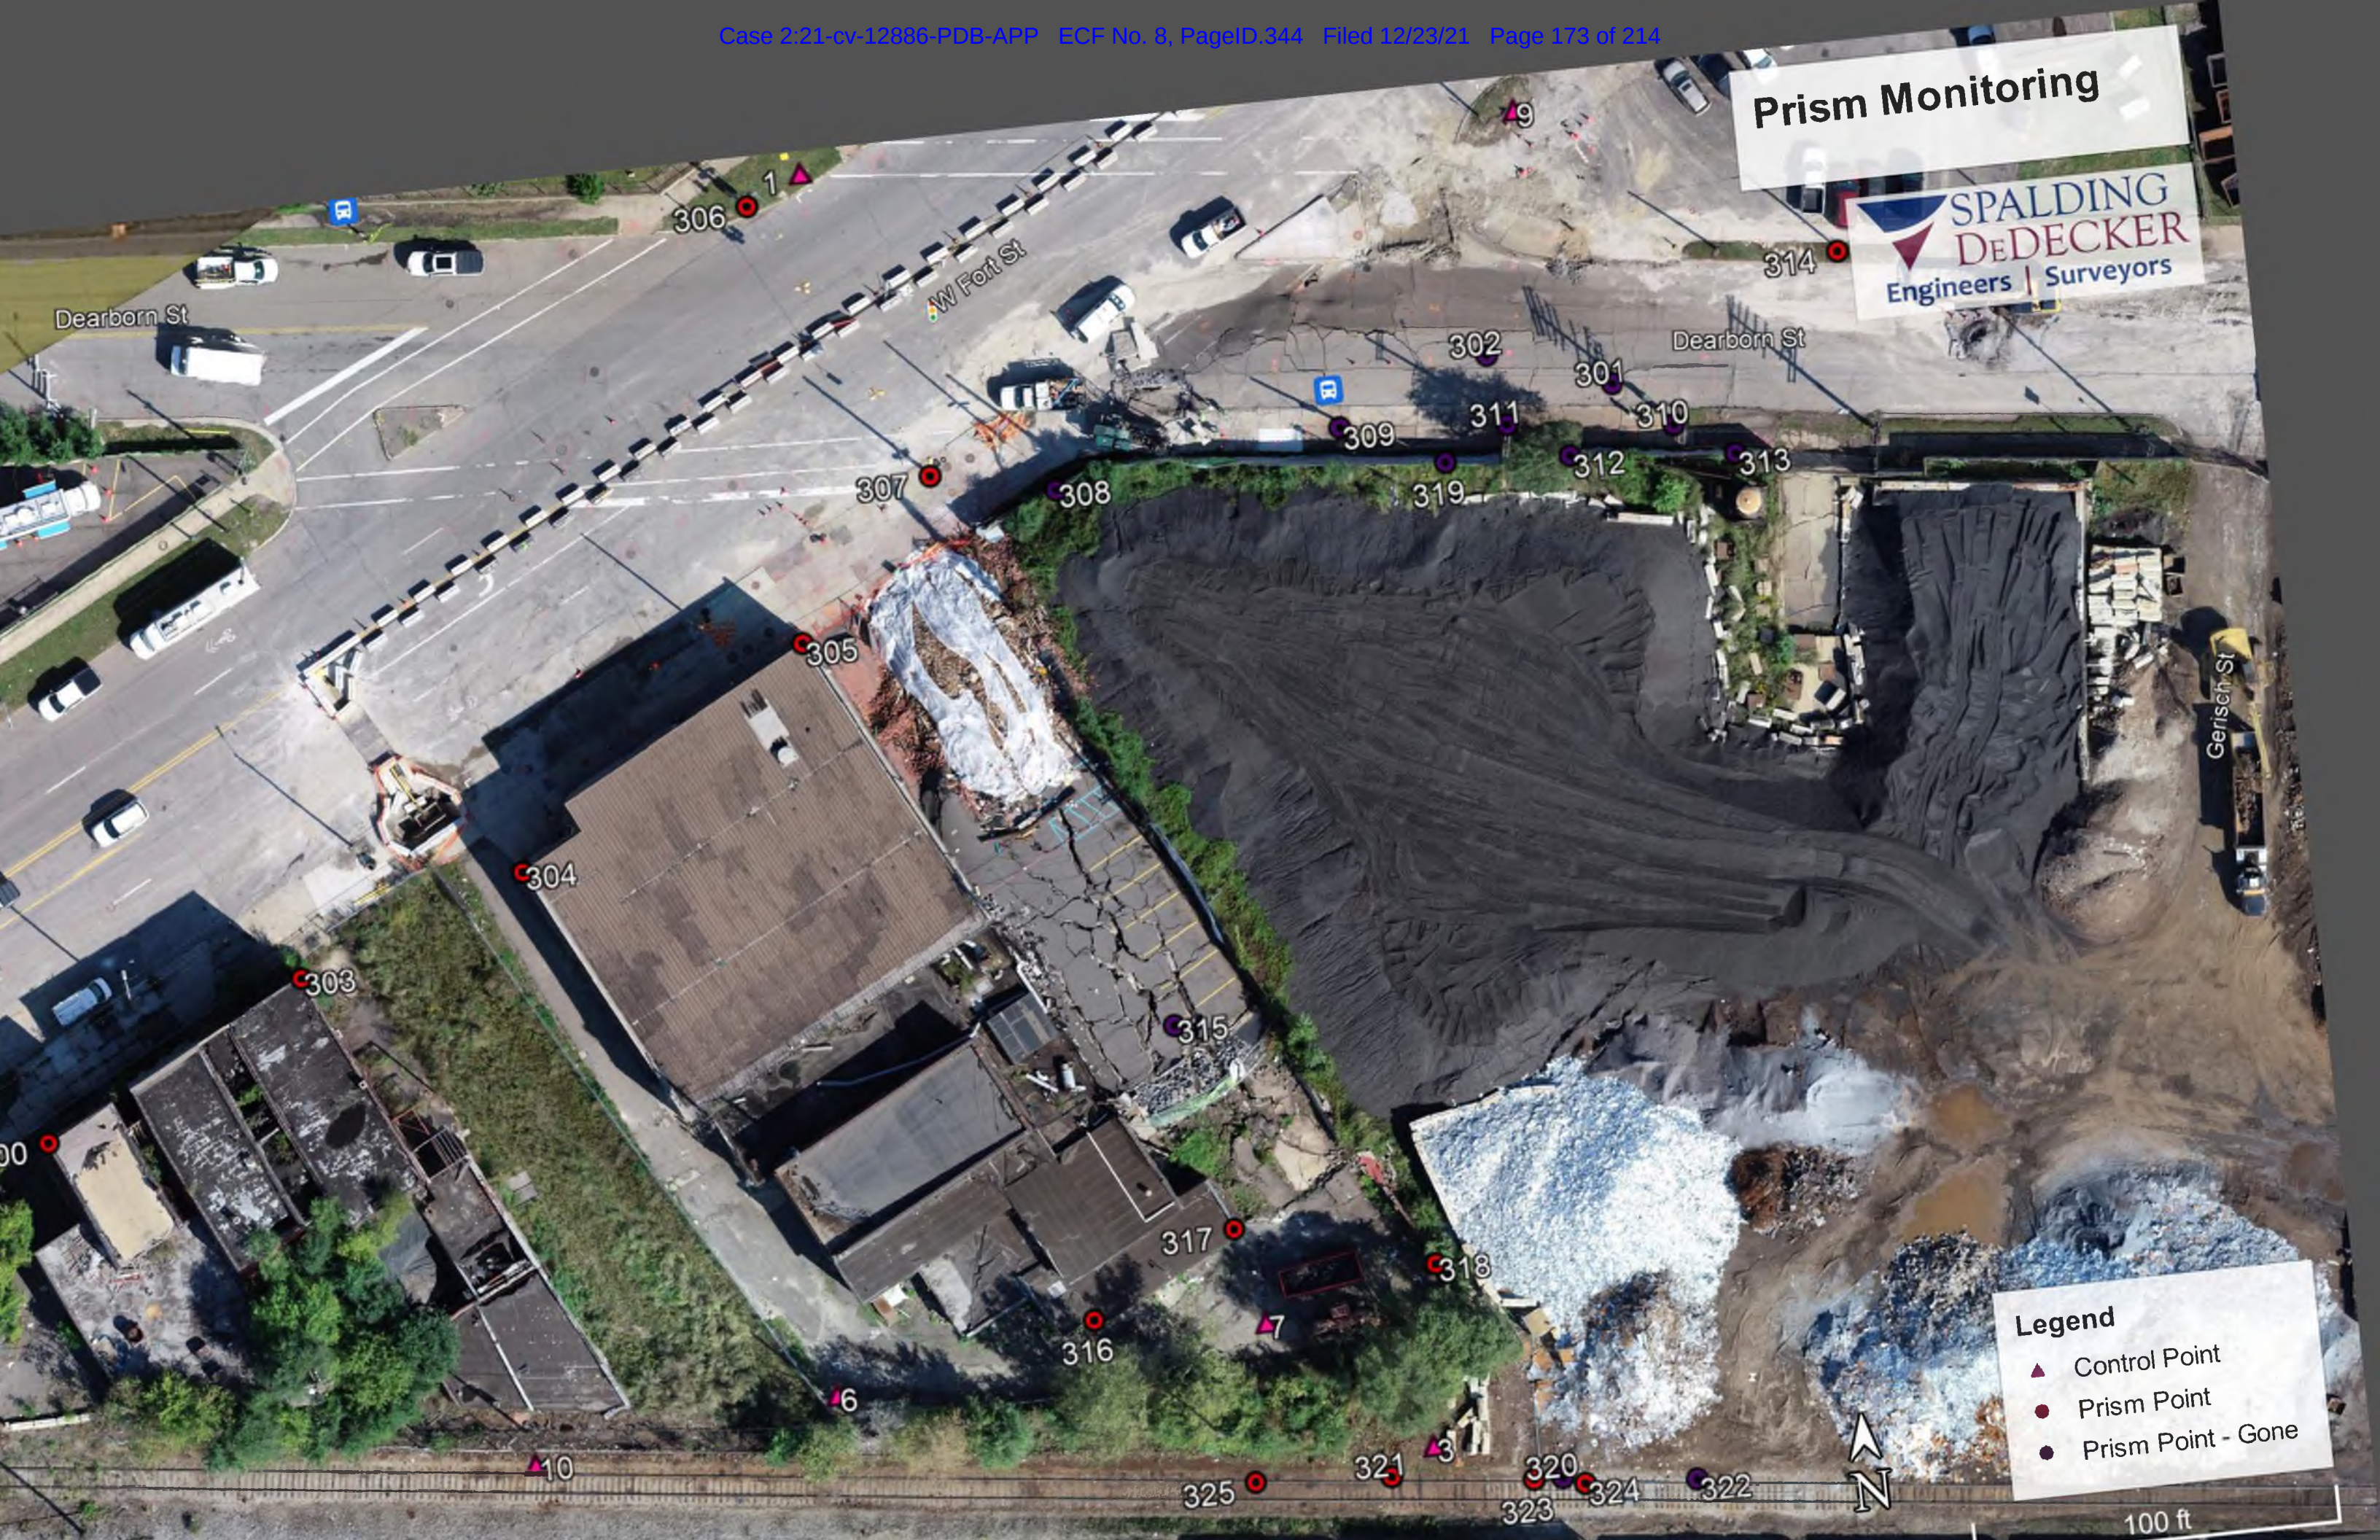
Prism Monitoring

- ▲ Control Point
- Prism Point
- Prism Point - Gone

It is our understanding that Area No. 1 has been cleared through the collaborative effort of Fort Iron & Metal and Great Lakes Water Authority (GLWA). It is our understanding that the current ground surface is at approximately Elevation 591.0. In addition, extensive ground surface monitoring points have been established and frequent readings have been recorded and forwarded to us. Our review indicates that since the installation of instruments, the current condition is generally static which indicates that current Fort Iron & Metal operations have not resulted in anything other than nominal ground movements. It is our opinion that the recorded movements are approximately within the accuracy of the instruments.
